Construction of Sendai Castle

Sendai Castle's Stone Walls

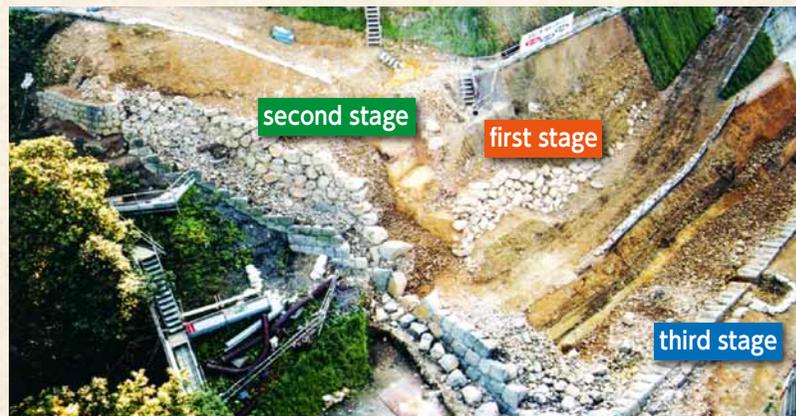
The Main Compound's north stone wall underwent repairs from 1997 to 2004, and in the excavation conducted during construction, an older stone wall, now known to be the second stone wall, was discovered underneath the current stone wall. An even older stone wall, the first stone wall, dates from the beginning of the 17th century when Masamune built the castle, and is made of natural, unhewn stones stacked with their longest side parallel to the wall. The subsequent second stone wall dates from the former half of the 17th century and is made of somewhat shaped natural stones stacked with their longest side perpendicular to the wall. The current third stone wall was built in the latter half of the 17th century during restoration after the 1668 earthquake, and is made of stones hewn on all sides stacked with the joints aligned.

Stone wall on the northeast side of the Main Compound (from the northeast)

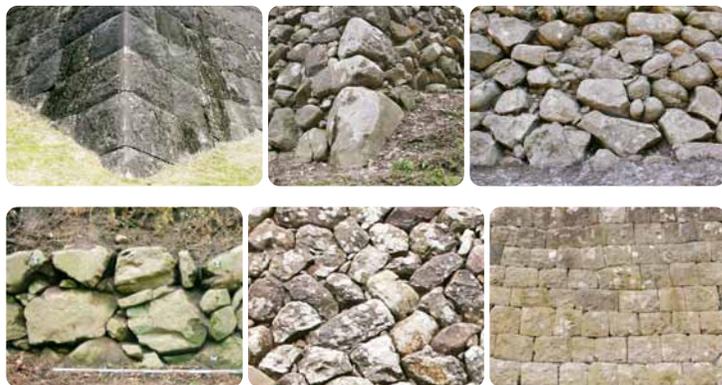
These are examples of various stone walls which allow you to study how those stones had been hewn and how the stones were stacked to form the walls around the castle.

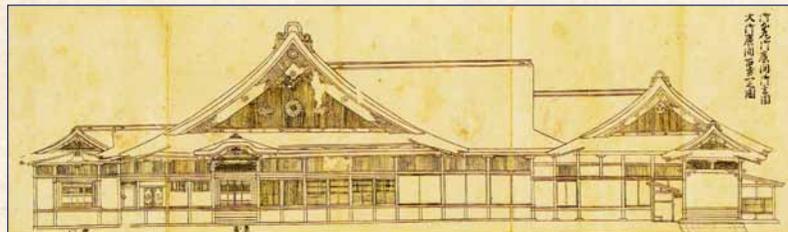
The Main Compound was divided into a public front half and private back half, and contained many buildings. The main building was the Ohiroma, completed in 1610. The Ohiroma was a magnificent building with a total of 14 rooms, and including the porch around its perimeter, had a floor area of about 430 tatami mats. To the north of the Ohiroma was a Noh stage, and another building overhung the cliff to the east.

Chida Family Drawing (Main Compound Ohiroma portion) (Sendai City Museum)

Please see our 1/50 scale model of the Ohiroma based on this drawing and excavations.

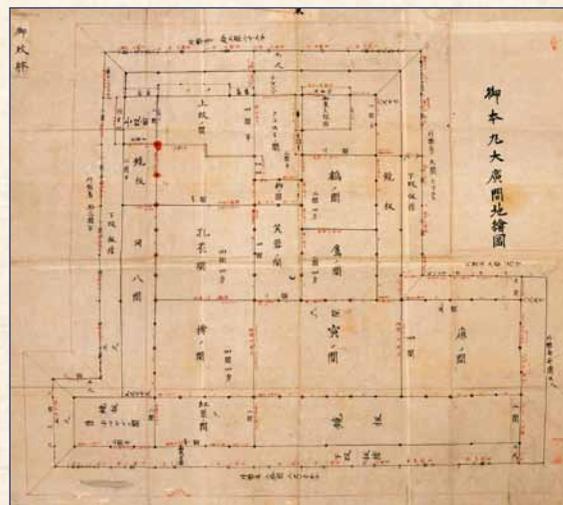
The Jodan-no-ma was a very formal room where the most important ceremonies and meetings between the feudal lord and his retainers were held. It was 7.9m wide, and the alcove contained a wall painting entitled Paulownia and Phoenix by Kano Sakyo. To the north was the Jojodan-no-ma, used during visits from the Imperial Family and the Shogun's family.

Floor Plan of the Main Compound's Ohiroma
